## Case Study

### PLATON MEMBRANE REPLACES FAILED SYSTEM

St Michael's Preparatory School was established in Jersey in 1949 and has operated from its current site in St Saviour since 1952. External waterproofing to the sports hall, constructed in 1994, had failed at wall/floor and floor/floor joints, leading to severe water ingress. St Helier based Premier Contracting used waterproofing products from Triton to replace the previous failed system before the sports floor was reinstated.

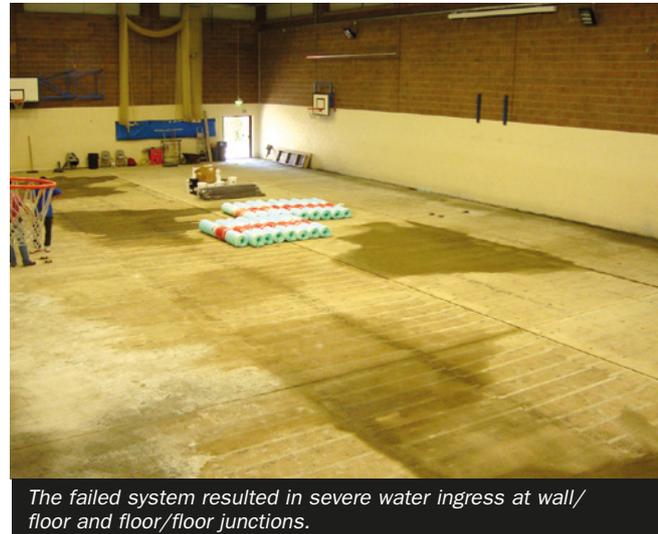
*The failed system resulted in severe water ingress at wall/floor and floor/floor junctions.*

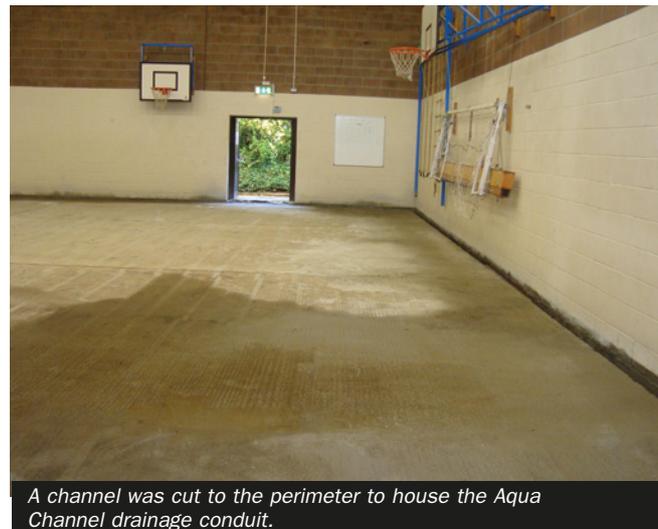
*A channel was cut to the perimeter to house the Aqua Channel drainage conduit.*

Triton Aqua Channel is designed to be used in conjunction with Platon Cavity Drain Membranes and is normally fitted to the perimeter of the floor. Any water enters the Aqua Channel through pre-drilled drainage holes and is then diverted to a suitable drainage point. Rodding eyes were installed every 10 linear metres to allow periodic maintenance of the system.

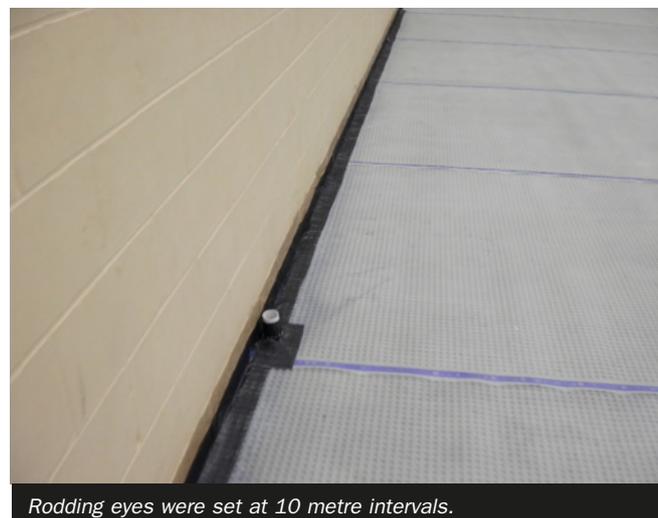
*Rodding eyes were set at 10 metre intervals.*

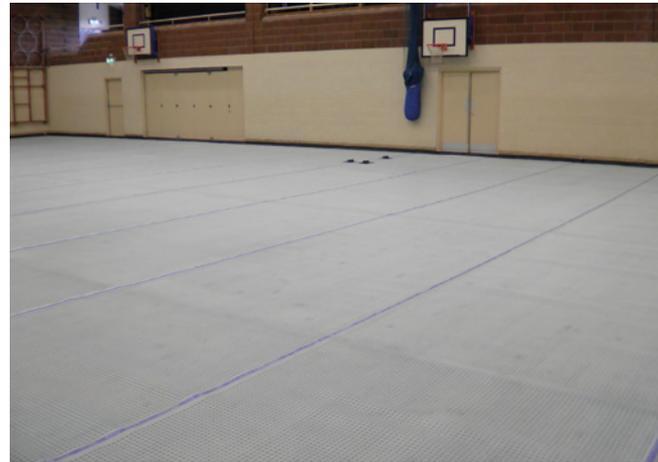
*Platon P8 was loose laid to the floor with minimal preparation required to the existing slab.*

BBA certified Platon P8 is a high-density polyethylene (HDPE) cavity drain membrane. It can be used to waterproof walls or floors and, following installation, its studded profile allows water to continue to penetrate the structure but then diverts it via the air gaps between the studs to the drainage point. Cavity Drain Membranes do not allow pressure to build up against the internal construction and the air gap behind them allows the structure to breathe and dry out. The membranes are loose laid on floors and fixed to walls using special plugs and sealing materials, with little or no preparation required to the substrate.

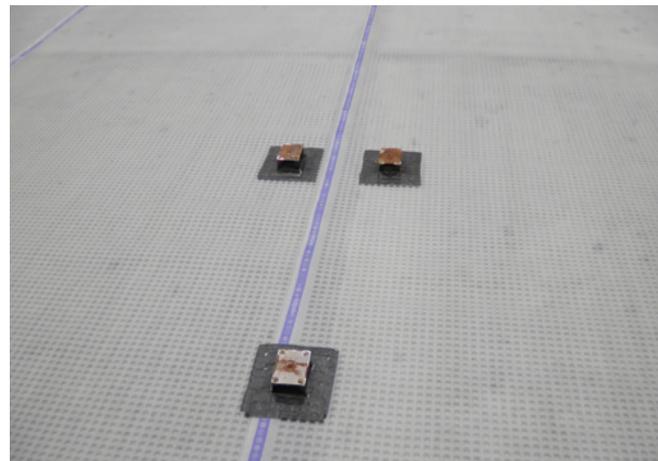
*A detail was designed to ensure the waterproofing system was not compromised by the gym apparatus fixings bolted to the concrete floor.*

A TT Vapour Membrane detail was also designed to ensure the waterproofing system was not compromised where the gym apparatus floor fixings were bolted into the concrete floor.

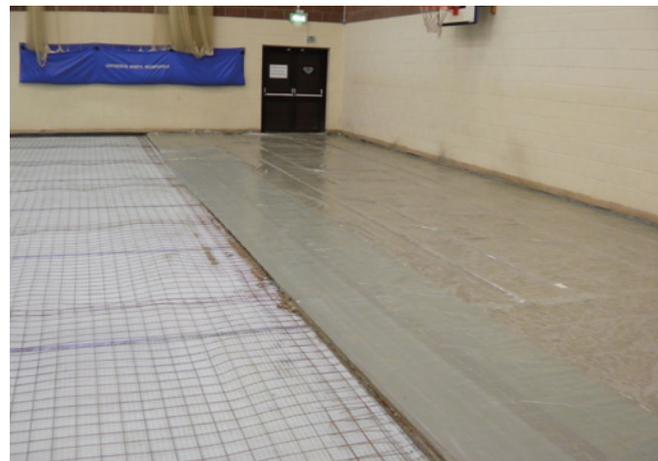
*Cavity drain membranes can be screeded over. A new sports floor was then installed to complete the refurbishment.*

Following installation of the new system, the membrane was screeded over and a wooden sports floor reinstated.
