Case Study

WATERPROOF BASEMENT EXTENDS NEW RESTAURANT FACILITIES

Pizza East

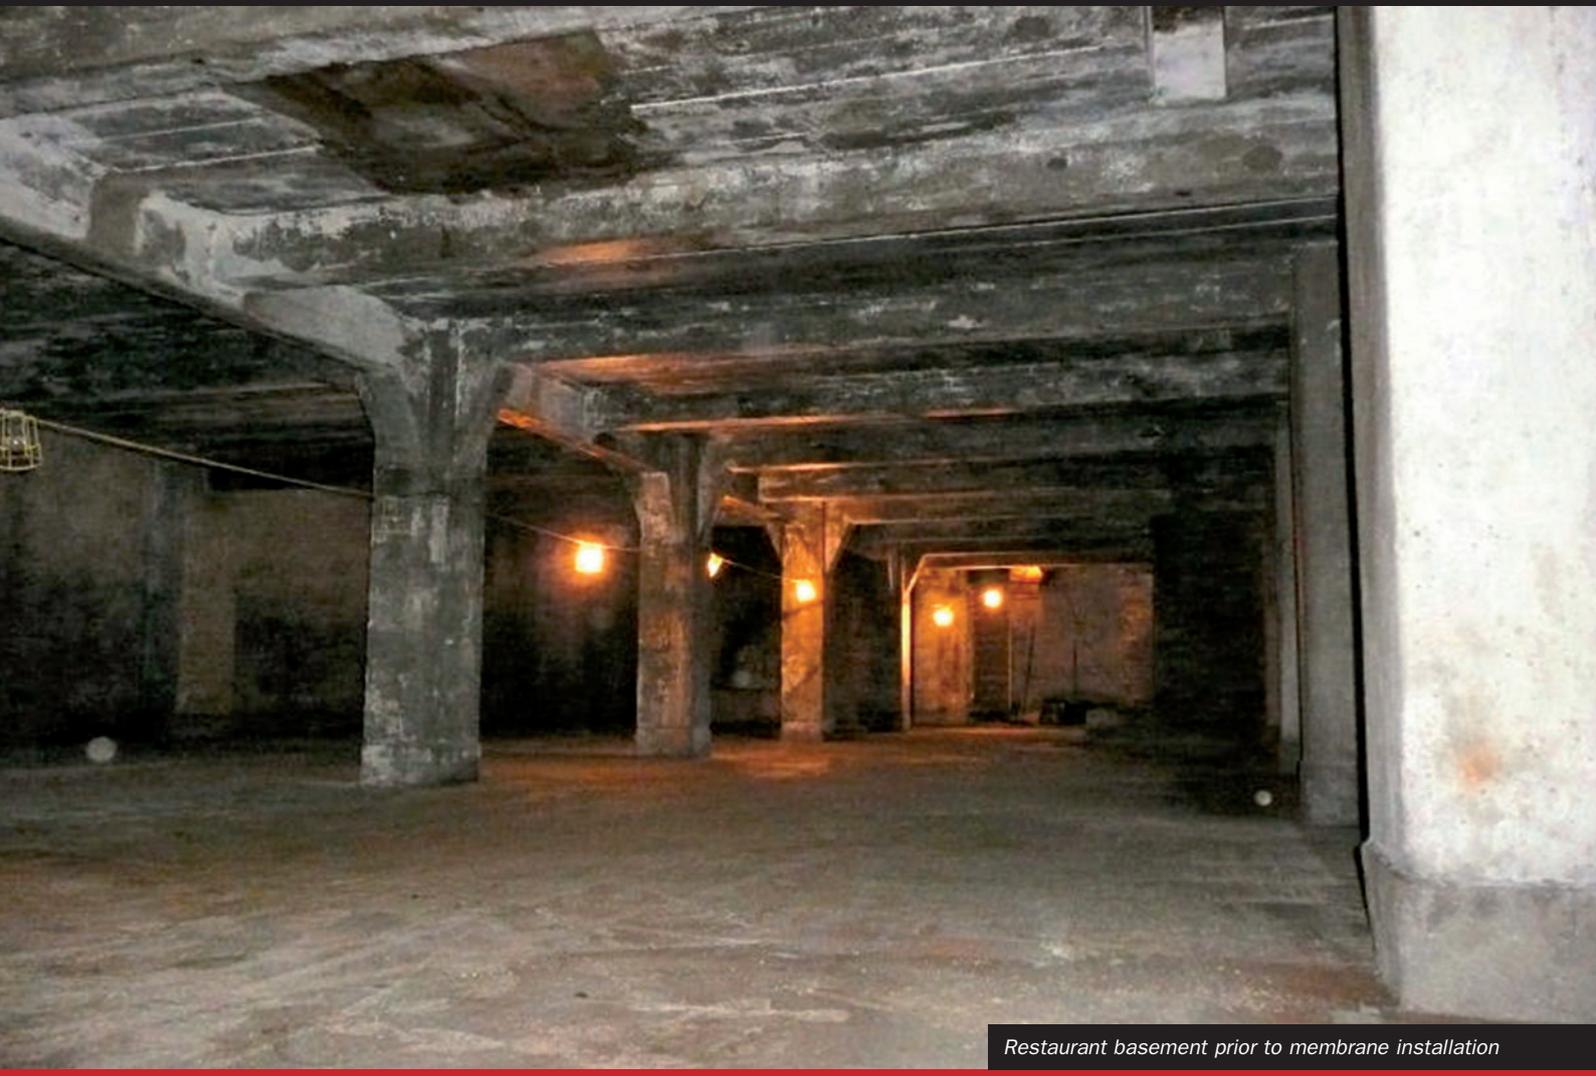
Restaurant basement prior to membrane installation

Triton's barrier and drained waterproofing systems have been used by Protectahome to waterproof the existing concrete cellar below a new restaurant. Part of the Soho House Group, Pizza East Kentish Town is a raw, stripped-back space with steel beams, wooden floors, huge windows, brickwork and bare concrete. The cellar offered potential for storage, food preparation, staff rooms and managers office with data connections, but was suffering from ground water ingress and rainwater ingress from the car park above.

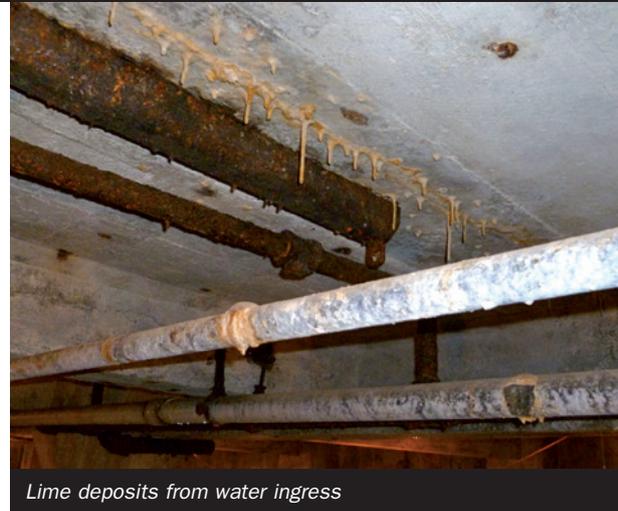
Lime deposits from water ingress

The concrete soffit was prepared and treated using Triton Repair Mortar, Triton Fillet Seal and Triton TT55 Waterproof Slurry. The TT55 was modified with Triton Tanking Mix Elastifier (TTME) to produce a more flexible waterproof coating. The remaining walls, floors and stanchions were primed with an anti-lime coating prior to the installation of the Platon cavity drain membrane system. The inclusion of an anti-lime coating within a waterproofing specification will reduce the amount of free lime leaching into the system – which may put the system under undue risk, and improve the water resistance of the basement.

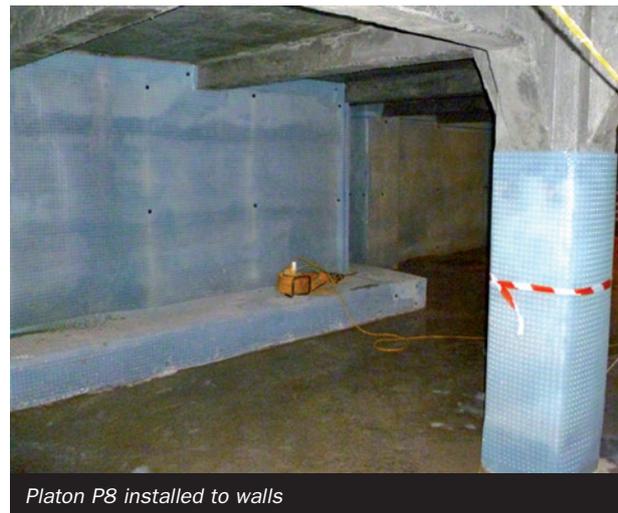
Platon P8 installed to walls

Platon P8 membrane was installed to the walls and deeper studded Platon P20 membrane laid to the floors. Any water still entering the building will be controlled behind the membrane and directed to and discharged from the drainage system. The integral drainage system comprised Triton Aqua Channel conduit fitted to the periphery of the area, which will direct any future water ingress to a Triton Aqua Pump Pro Sump, which contains the high water alarm, mains powered pump and battery back up pump which would be activated in case of mains failure.
