## Triton Systems

TIE BOLT HOLE SEAL

TYPE B INTEGRAL WATERPROOFING TT ADMIX

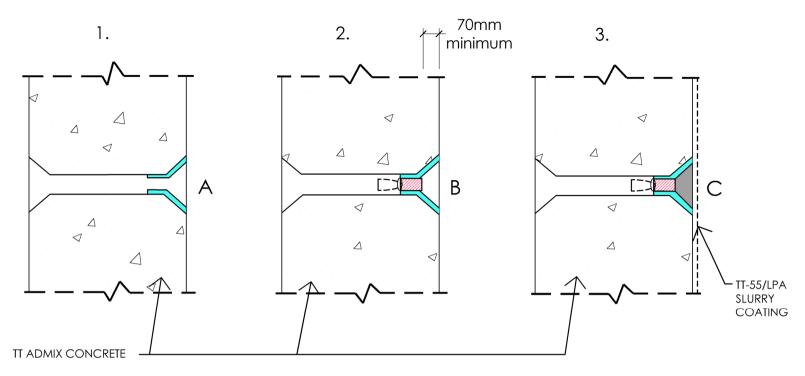
TIE BOLT CONES TO BE REMOVED
TIE BOLT SLEEVE CAN REMAIN IN-SITU.

A. CONED AREA IS CLEANED AND PRIMED WITH TRITON LPA PRIMER:

B. SILICONE RUBER PLUG FITTED. 20MM DEPTH TT SWELLMASTIC INJECTED:

C. FINISHED FLUSH WITH TRITON REPAIR MORTAR. OVERCOAT WITH TT-55/LPA SLURRY

\*BOTH SIDES TO BE SEALED\*
